MICROSTRUCTURE AND FATIGUE BEHAVIOR OF THREE NICKEL  
BASE EUTECTIC COMPOS. (U) RENSSELAER POLYTECHNIC INST  
TROY NY DEPT OF MATERIALS ENGINEE..

Technical Report No. 3  
to  
Air Force Office of Scientific Research  
under  
Grant No. AFOSR-80-0015  
by  
K.A. Dannemann, N.S. Stoloff & D.J. Duquette  
Materials Engineering Department  
Rensselaer Polytechnic Institute  
Troy, NY 12181  
November 30, 1982

4. TITLE (and Subtitle) <b>MICROSTRUCTURE AND FATIGUE BEHAVIOR OF THREE NICKEL BASE EUTECTIC COMPOSITES</b>		5. TYPE OF REPORT & PERIOD COVERED <b>Technical 12/1/81 - 11/30/82</b>

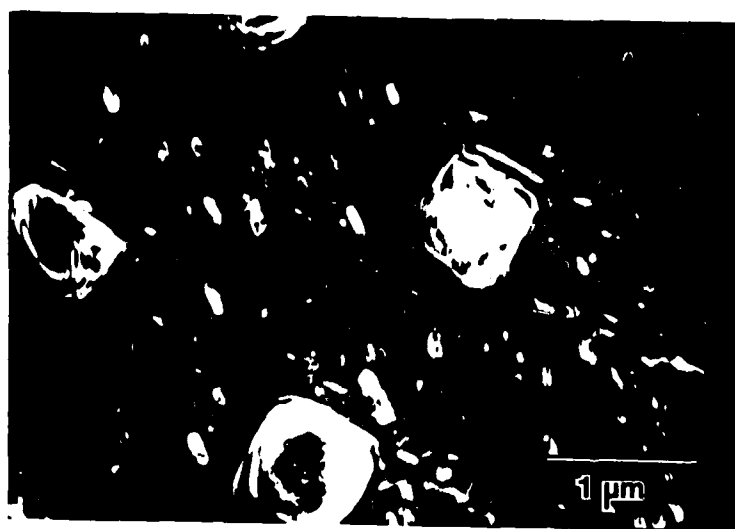
Fig. 13 Microstructures of AG-170. (c) Partially solutionized and aged 4h at 850°C. (d) Dark field image accentuating Mo-rich precipitates of (c).

Aging in vacuum for 4 hours at  $850^{\circ}\text{C}$  caused a new phase to precipitate. Fig. 13c depicts the precipitates which were formed in the  $\gamma'$  phase after a 24 hour aging treatment. The dark field image, Fig. 13d, gives an even clearer view of these elliptical precipitates.

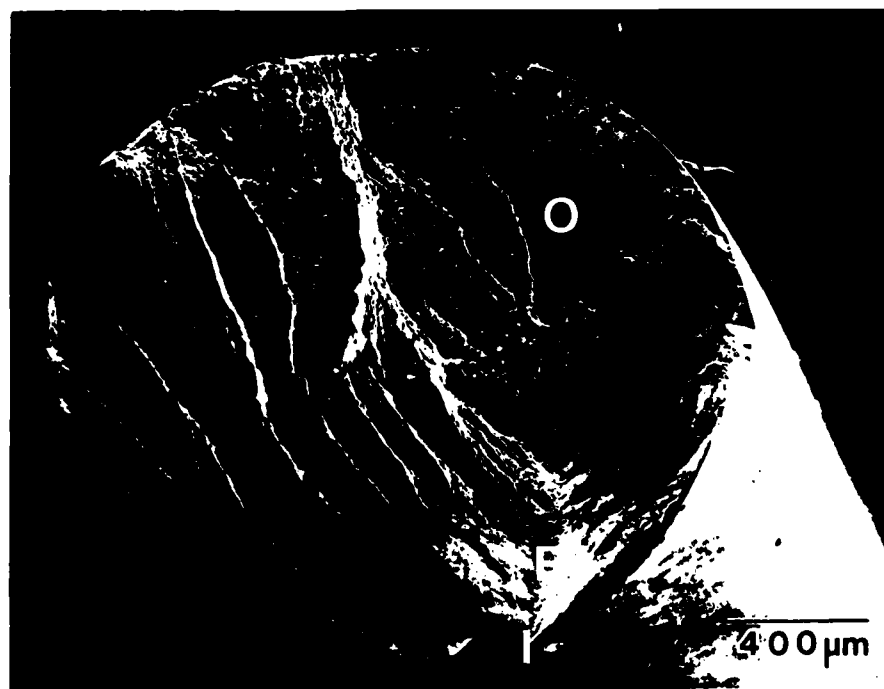
Fig. 25 Fracture profile of room temperature fatigue failure of Nitac 14B illustrating three distinct regions: I - initiation site, F - fatigue zone, O - overload zone.

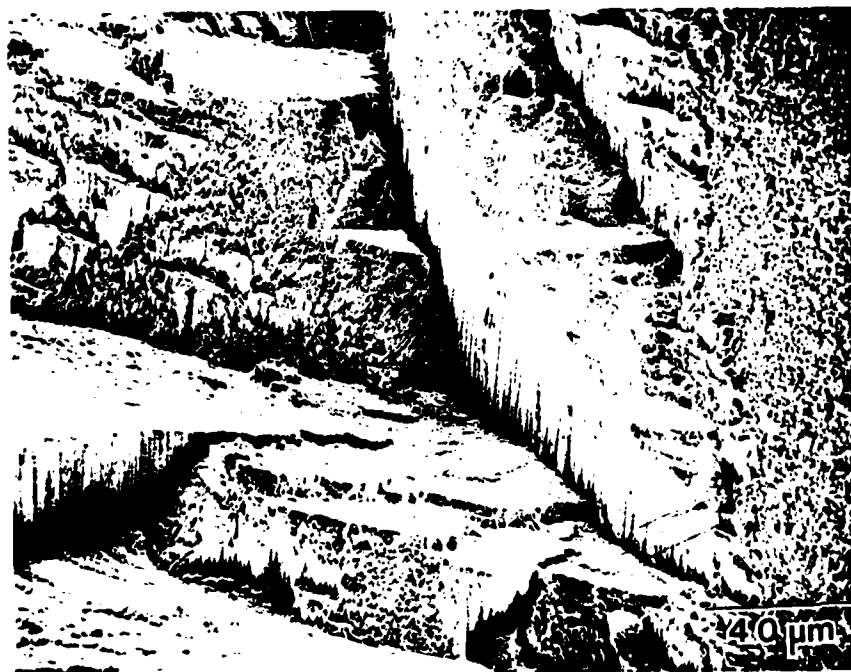
Fig. 27 Characteristic (a) surface origin and (b) Stage I cracking for an AG-170 specimen tested at 25°C and  $\Delta\sigma = 1100$  MPa.

At 25°C, fatigue cracks in all of the as D.S. alloys initiated at the specimen surface. Fig. 26 depicts a representative surface initiation site in Cotac 744 at  $\Delta\sigma = 1000$  MPa after  $4.5 \times 10^6$  cycles. Upon careful examination, Stage I cracking is visible in both Fig. 25 and 26. AG-170 also shows evidence of Stage I cracking in the vicinity of the surface initiation site. Fig. 27a illustrates a surface initiation site for a specimen stressed at 1100 MPa. Crack propagation can be seen to be along crystal planes. These planes are magnified in Fig. 27b for easier viewing.

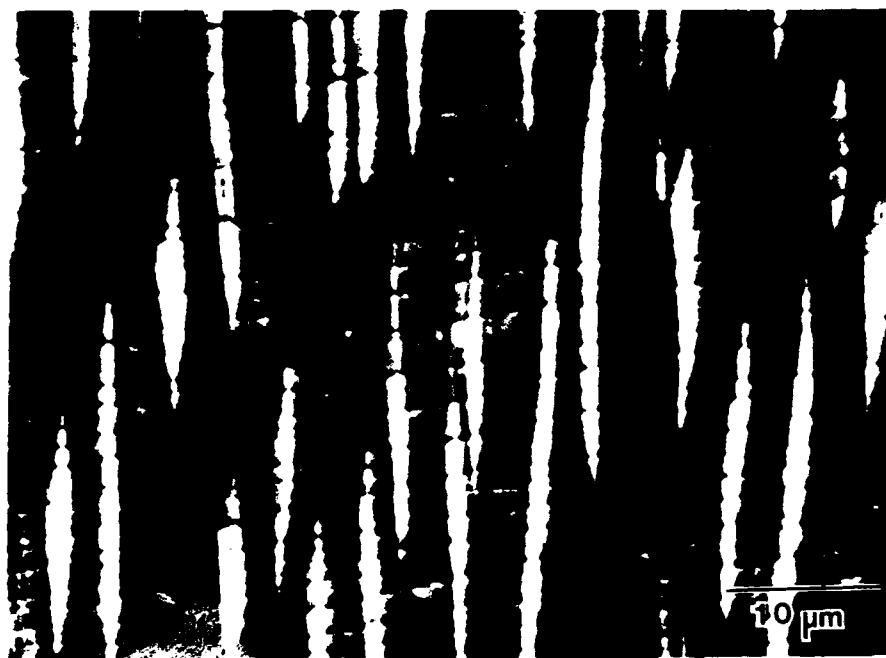
Fig. 28 (c) Side surfaces of AG-170 after room temperature fatigue, showing crystallographic cracking only for the carbide-reinforced eutectics.

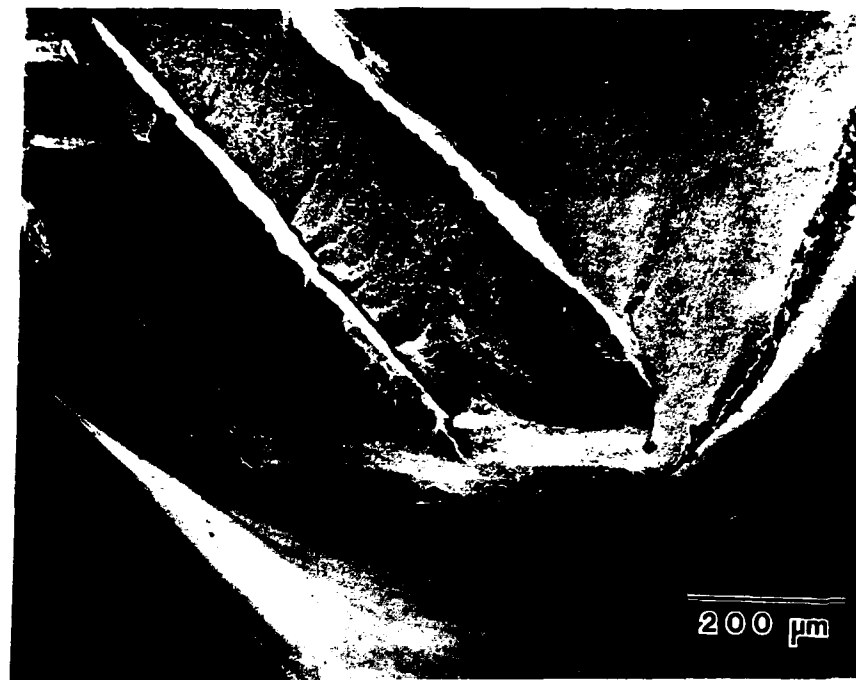
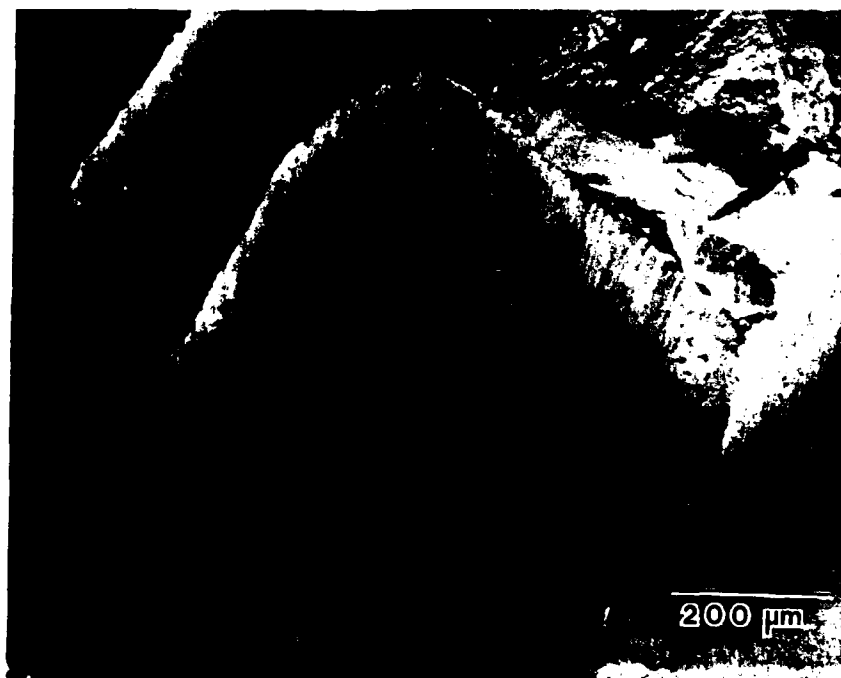
Fig. 39 SEM Fractographs of "aligned", partially solution treated AG-170, tested in fatigue at 25°C and  $\Delta\sigma = 1034$  MPa.  
(a) Surface initiation site. (b) Secondary cracks.

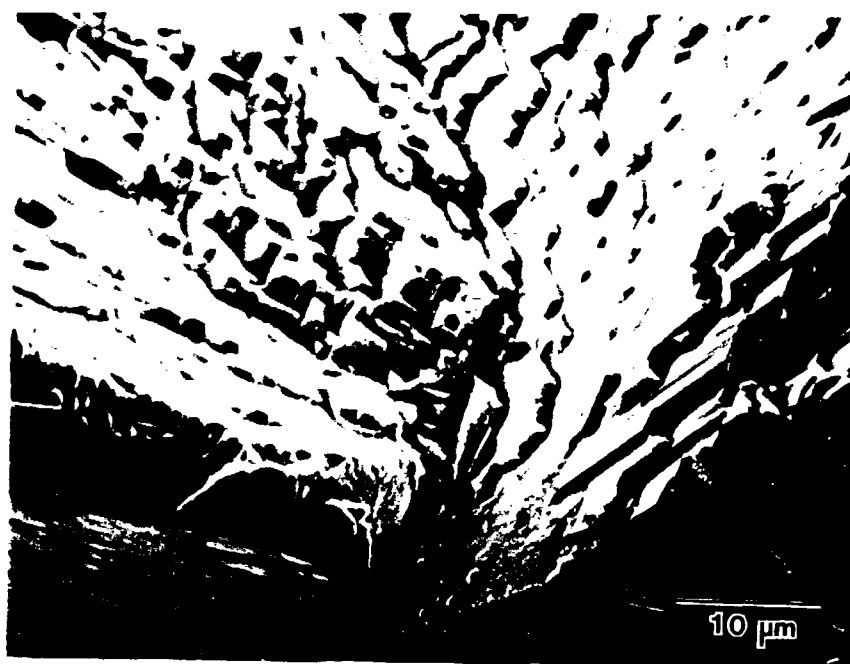
Fig. 45 Surface initiation and Stage I cracking in aged Cotac 744, tested at 25°C.

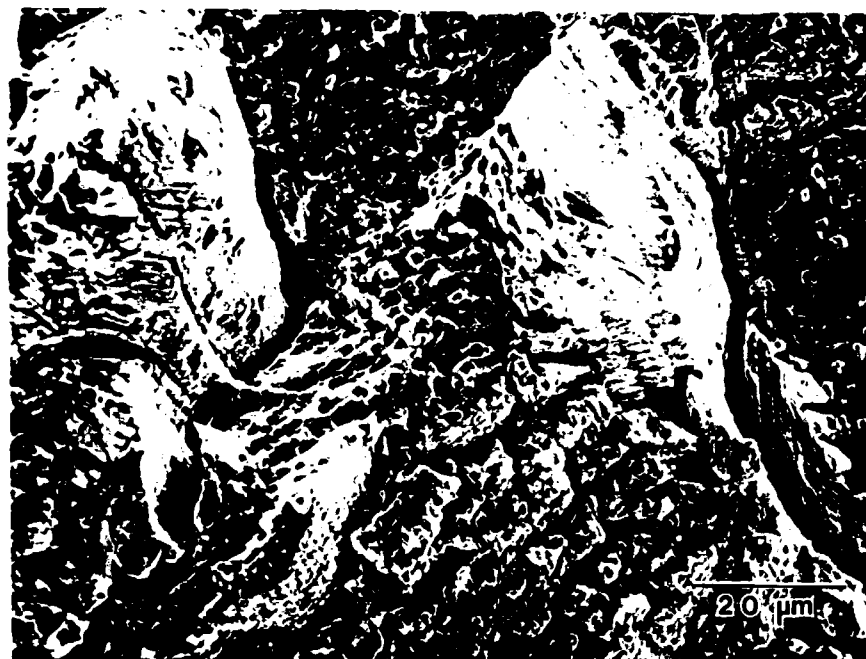
Fig. 47 Grain boundary cracking in the sample shown in Fig. 46.  
(a) Steep grain boundary cracks. (b) Magnified view of the crack wall.

Considerably more grain boundary cracking has been observed in the aged alloys. Inspection of the transverse microstructure of a specimen which had been tested at a stress level of 931 MPa yielded a cellular structure as shown in Fig. 46. This was not unforeseen in view of the large amount of cell boundary cracking noted in this sample. Fig. 47 depicts a few of these internal cracks. Steep grain boundary walls clearly encompass the more ductile transgranular dimpled region.
